CRASH RESEARCH & ANALYSIS, INC.

ON-SITE AMBULANCE CRASH INVESTIGATION

SCI CASE NO: CR12002

VEHICLE: 2011 FORD E350 CHASSIS

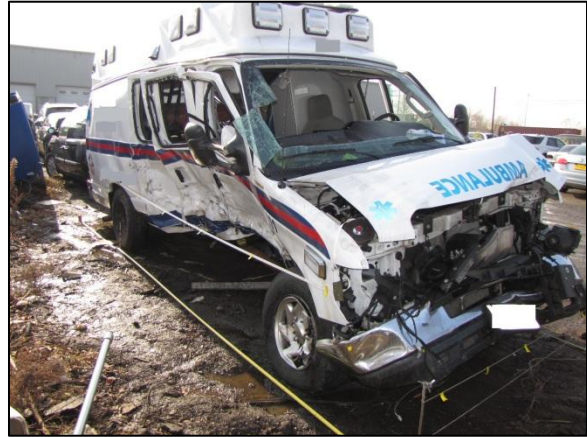
Figure 1: Front right view of the Ford ambulance.

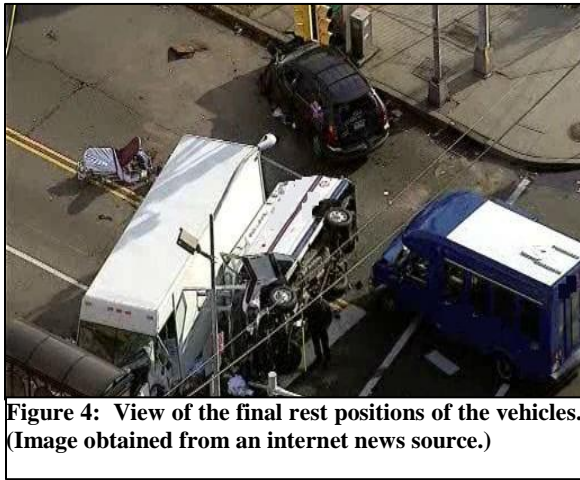
Figure 4 is an on-scene image taken by local media coverage which documented the crash. The final rest positions of the vehicles were located on the east leg of the road immediately to the east of the intersection. At the time of the SCI scene inspection, the only residual physical evidence was four short tire marks that were observed on painted lines of the east leg road in the northeast intersection quadrant. The marks measured 0.7 m (2.2 ft) in greatest length and were attributed to the right tires of the Workhorse as it slid to final rest. **Figure 5** is an image of the final rest

Figure 4: View of the final rest positions of the vehicles. (Image obtained from an internet news source.)

The vehicles separated and traveled to their final rest positions. The Workhorse rotated approximately 80 degrees CW and came to rest facing north adjacent to the bus stop on the east leg of the intersection. The tire marks identified during the SCI scene inspection were used to reconstruct post-impact movement. The ambulance completed a right side leading one-quarter turn rollover and came to rest on its right plane, facing north in an orientation parallel to the Workhorse. The Chrysler was displaced forward to its final rest position adjacent to the south curb on the east leg of the intersection. The Ford transit bus came to rest facing east, immediately to the west of the ambulance. The rest positions of the vehicles were documented in **Figure 4** (the on-scene news image) above.

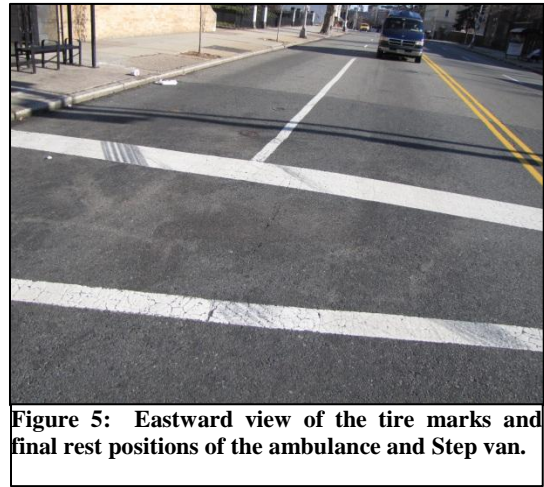
locations of the ambulance and Workhorse taken during the SCI inspection. The tire marks attributed to the post-impact movement of the Workhorse are visible in the image.

Figure 5: Eastward view of the tire marks and final rest positions of the ambulance and Step van.

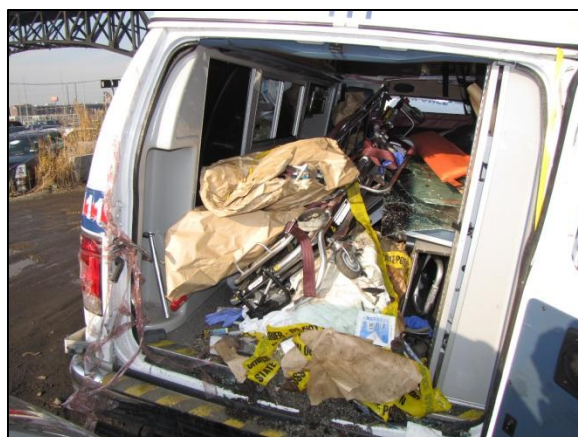
The Type II patient compartment was a 2K model manufactured by AEV of Jefferson, NC. The standard layout of the interior featured a rear-facing attendant’s seat, an inward facing bench seat along the right wall and multiple storage shelving and cabinetry. All cabinets were constructed of 19 mm (3/4 in) plywood, were trimmed with 3 cm (1 in) aluminum, and had sliding plexi-glass doors. The trim was attached to the cabinets with glued wood dowel fasteners. **Figure 10** is a view of the interior taken at the time of the SCI inspection prior to removing any items. The stretcher was loose inside the ambulance floor having been previously removed by the first responders. The ambulance and patient compartment had also been inspected by the NJDOH. Numerous supplies had been displaced from the installed cabinetry by the force of the impacts and debris from the crash site had also been loaded into the interior.

Figure 10: View of the patient compartment at the time of the SCI inspection.

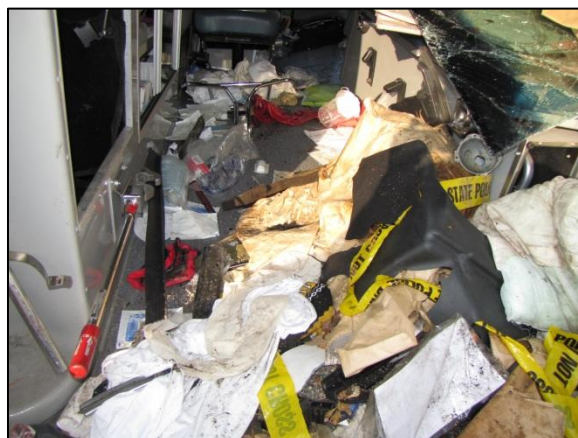
Figure 15 is a view of the antler bracket mounted to the patient compartment floor and the Stryker Model No: 6371 rail clamp that was mounted to the left wall. There was no deformation of the antler bracket and the stretcher wheels/frame remained engaged with the bracket during the crash. The rail clamp was not deformed and operated properly at the time of the SCI inspection.

Figure 15: View of the patient compartment's antler bracket and floor clamp.

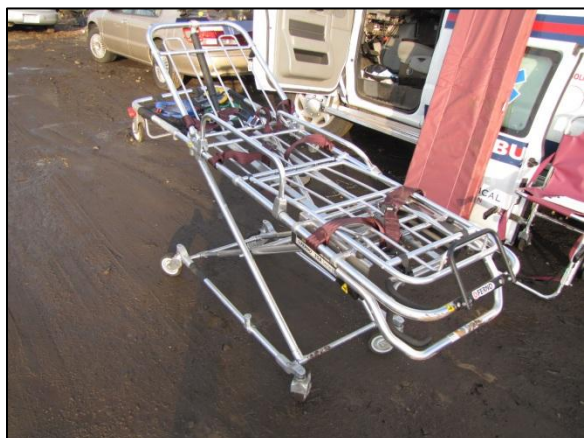
The patient stretcher was a Ferno Model 35A, Serial No: 208915 (**Figure 16**). The stretcher was rated for a 227 kg (500 lb) load capacity.

Figure 16: View of the Ferno stretcher.

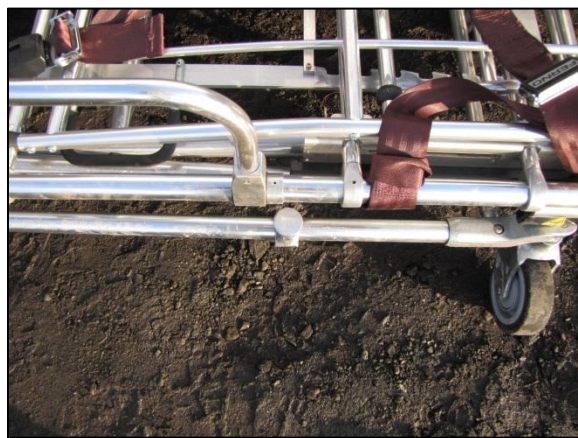
The X-frame stretcher was manufactured from aluminum tubing and measured 201 cm x 61 cm (79 in x 24 in) in overall dimensions. The frame properly raised and lowered. The locking pin attached to the right longitudinal frame rail was intact and undamaged (**Figure 17**). The back rest was adjustable over a range of approximately 75 degrees via a manual pneumatic shock absorber. The stretcher was equipped with three lateral restraints. Each lateral restraint consisted of adjustable length webbings with a locking latch plate. The fixed ends of the webbing were attached to the side frame of the stretcher. The stretcher was not equipped with a shoulder harness.

Figure 17: Close-up view of the stretcher's locking pin

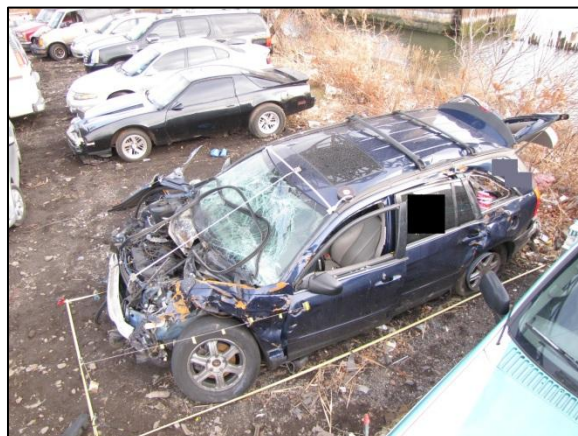
Figure 18: Overhead view of the Chrysler.

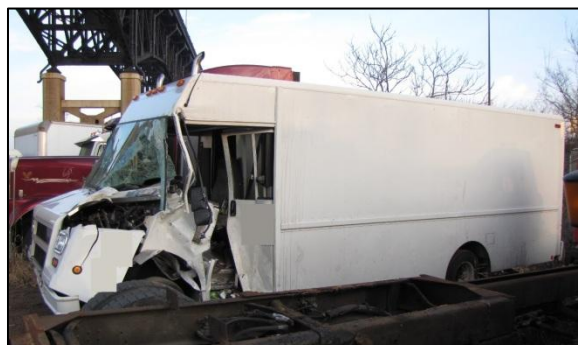
Figure 22: Left side view of the Workhorse step van.
